Rajakudakan Wat Chotikaram: From Ruins to The Reconstruction of The Grand Stupa, Wat Chedi Luang, Chiang Mai*

The Grand Stupa is mentioned in historical text as ‘Rajakudakan’, which means a royal building with a multitiered superstructure. This Grand Stupa is the principal construction of Wat Chedi Luang, and marks the center of the Chiang Mai City Plan.

Keywords: Wat Chedi Luang, Lanna, point cloud images, heritage building information modelling, reconstruction supposition

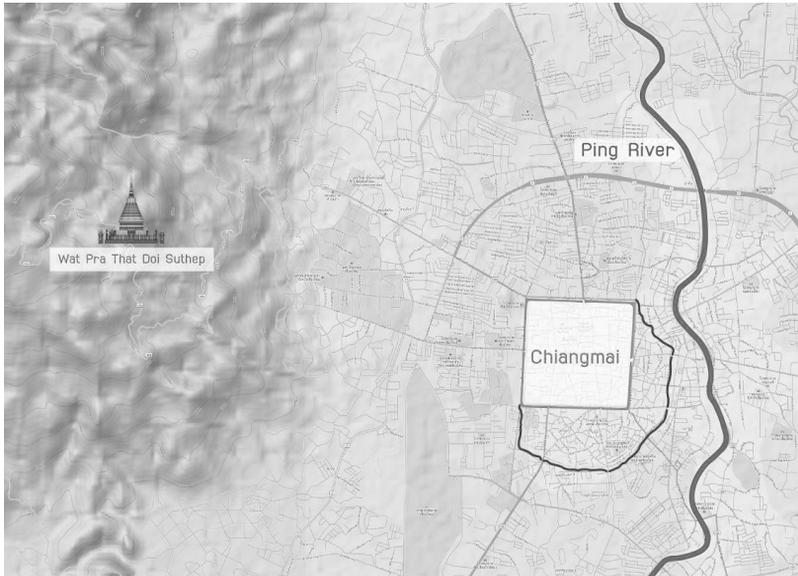
<Fig. 2> Geography of Chiang Mai City flanked by Mae Ping River in the east and the Suthep Mountain in the west

Chiang Mai City was established by King Mangrai in 1296 on the hugely abundant lowland flanked by Mae Ping River and Suthep Mountain, featuring a perfect location of an urban settlement <Fig. 2>. The city was given a convenient canal journey through Mae Ping River and the lowlands of the east, suited for the traditional irrigation of dikes and irrigation systems (Mueang Fai), which were typically invented by Tai-speaking people to divert river for farming. Considerably, this traditional irrigation contributed to the security of food and administration that Chiang Mai was able to centralize a huge group of traditional states of 'Lanna'.

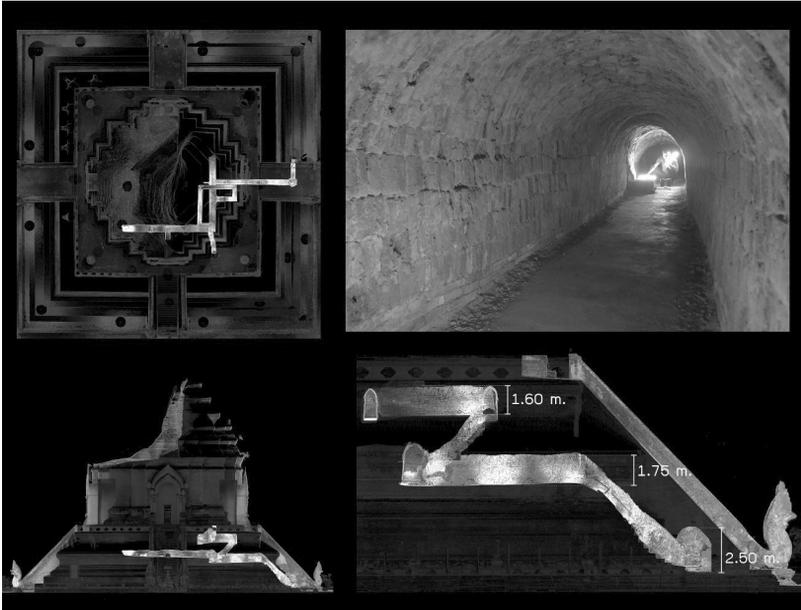
<Fig. 7> Walkway tunnels inside the Grand Stupa, Wat Chedi Luang

From the survey of the walkway tunnel in a particular part under the exterior ramp, the design was clearly rendered in a form of a steep slope; and its sloping sides join at the ridge, which is exactly

related to the stair slope and designated by the exterior ramp form. In addition, the formation of the bricks of this tunnel was systematically arranged, and each riser of the stairs relatively changed its height according to the levels of the ceiling (No.1). The next part is a straight line of tunnel (No.2), intersections-ending at T (No.3). The junction to the right is a short distance thoroughly closed by compacted rubble and clay (No.4). Heading to the left (No.5) approximately 2 meters can meet another higher tunnel on the left (No.6). This left subordinate walkway (No.5) features a sharp turn (No.6), and its floor is so compacted that people cannot stand this area, as ceiling are low (1.5 meters). The end of this subordinate walkway (No.7) is fully compacted with rubble and clay <Fig. 7>.

Turning back to the mouth of the tunnel (No.6), this walkway connects to another higher tunnel, featuring identical stairs (No.7) to the stairs at the entrance (No.1), and slightly leads to a sharp turn and a dead end. Moreover, a further dug tunnel, which deviates from the circumambulatory terrace of the upper exterior stupa, is found. This additional tunnel is later dug; it also features marks of breaking bricks and laterites, possibly left after the archaeological excavation and the conservation by the Fine Arts Department to create a connecting tunnel to the circumambulatory terrace above the outside of the stupa (Phetpradap 1986: 18).

Notably, based on the survey, the formation of the bricks of the first-level tunnels is more systematically arranged than the second-level tunnels. A fruitful outcome is also evaluated from the results of the 3D laser scanner, and the tunnel survey reveals a significant engineering problem that the tunnels bear massive-dead loads, resulting in their great collapse during the earthquake due to unstable bases with interior tunnels.
